Manhole Inspection Summary

Manhole # S15YY_018MH

Insp Date: **11/11/08 2:29 PM**

Location Address: **3526 OVERVIEW RD**

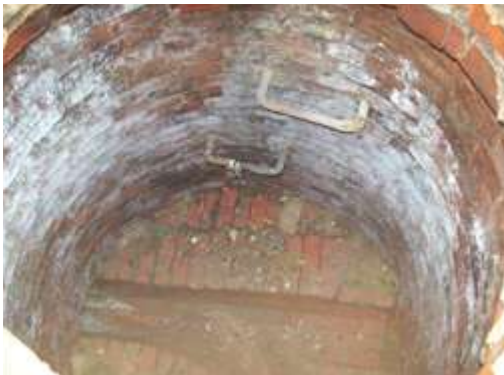
Defect 1

☒ **Evidence Of Surcharge** Depth: **2** (ft.) ☐ Active Surcharge Present

EVIDENCE OF ASUR

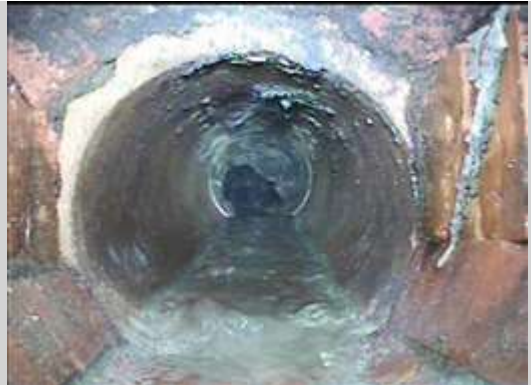
12 O'Clock Outflow

8 in. Circular Gravity Sewer
Pipe Out @ 12 O'Clock

Invert Depth: **6.38** (ft.) Flow Characteristics: **Fast**

Infiltration: **None** Pipe Seal Cond: **Sound**

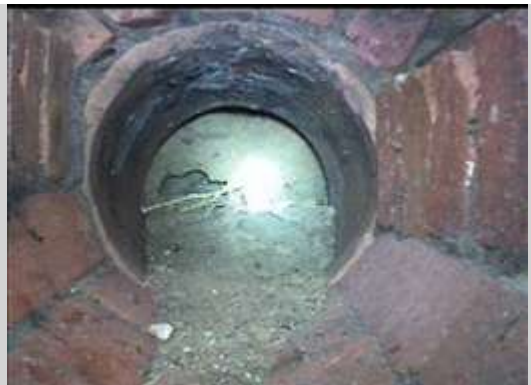
6 O'Clock Inflow

8 in. Circular Gravity Sewer
Pipe In @ 6 O'Clock

Deposits: ☐ None ☐ Mud ☐ Sludge ☒ **Debris** ☐ Grease

Silt Depth: **8** (in.) Deposits Extent: **Heavy**

Connects To: **Stub connection / abandoned**

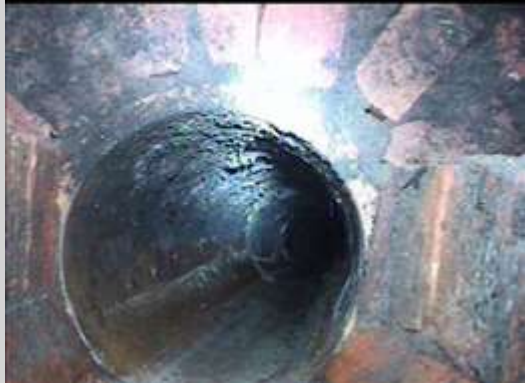
9 O'Clock Inflow

8 in. Circular Gravity Sewer

Pipe In @ 9 O'Clock

Invert Depth: **6.18** (ft.) Flow Characteristics: **Fast**

Infiltration: **None** Pipe Seal Cond: **Sound**
